USAAEFA PROJECT NO. 79-07

**ARTIFICIAL AND NATURAL ICING TEST  
OF THE YCH-47D**

**FINAL REPORT**

**JULY 1981**

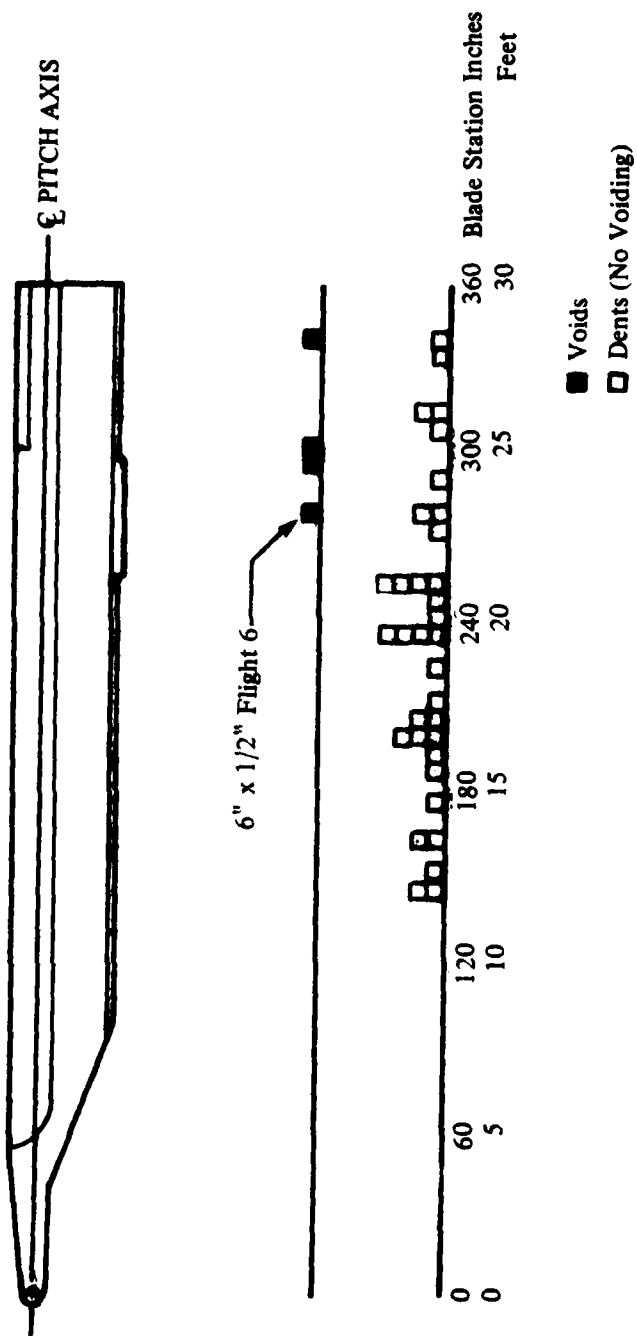
Figure 2. Ice Damage to the Bottom of the Fwd Rotor Blades

25. Small dents and voids were detected during postflight inspection on the underside of the forward and aft rotor blades. Figures 2 and 3 show the location of all blade damage encountered during the icing tests. The majority of the dents were incurred during the natural icing flights conducted at  $V_{mcp}$  airspeeds (flights 14, 17, 18, and 20). The largest blade void occurred during flight 9, behind the HISS, at a flow calibrated LWC of 1.2 gm/m<sup>3</sup> and -10° C (photo 7, app E). The voids marked with an arrow in figures 2 and 3 reflect blade damage that required repair (para 27). Annotations show the size of the damage and flight number. The YCH-47D, with unheated blades, can operate continuously at temperatures down to -5° C with up to 0.5 gm/m<sup>3</sup> LWC without incurring significant blade damage or asymmetric shedding. An ice detector is necessary to give the pilot an indication of the icing conditions, so he can keep the aircraft within established limits.

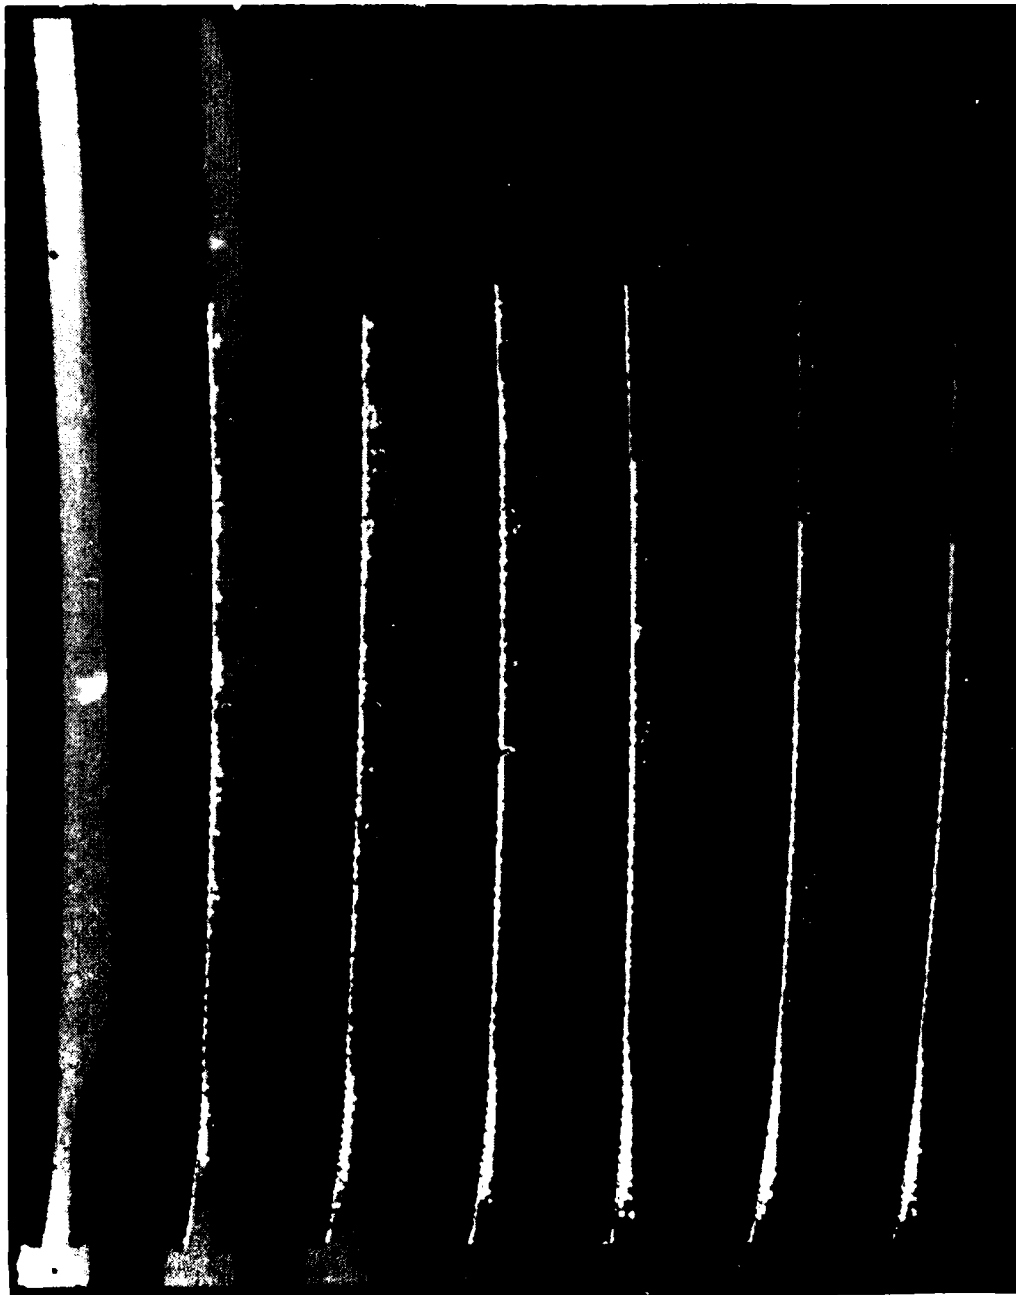
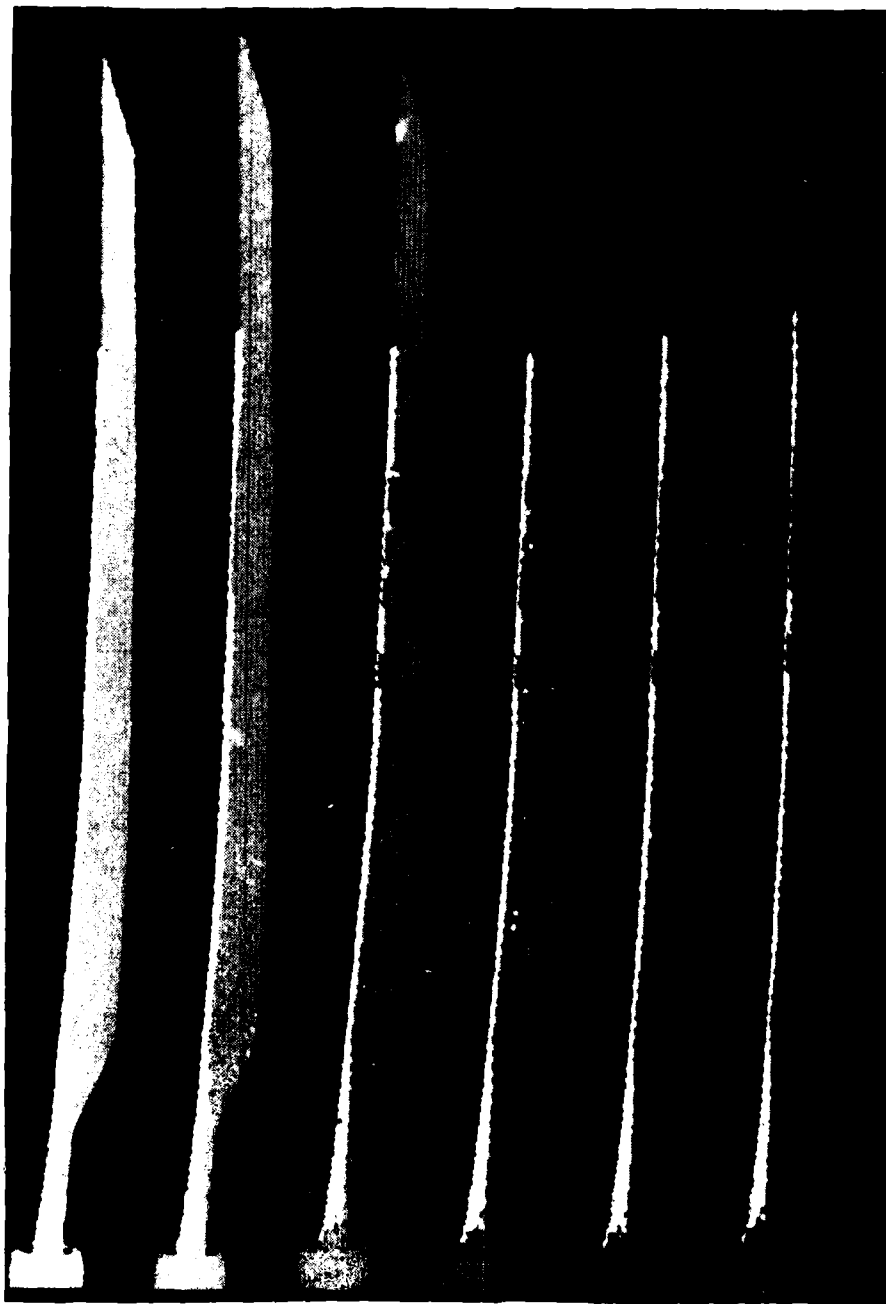
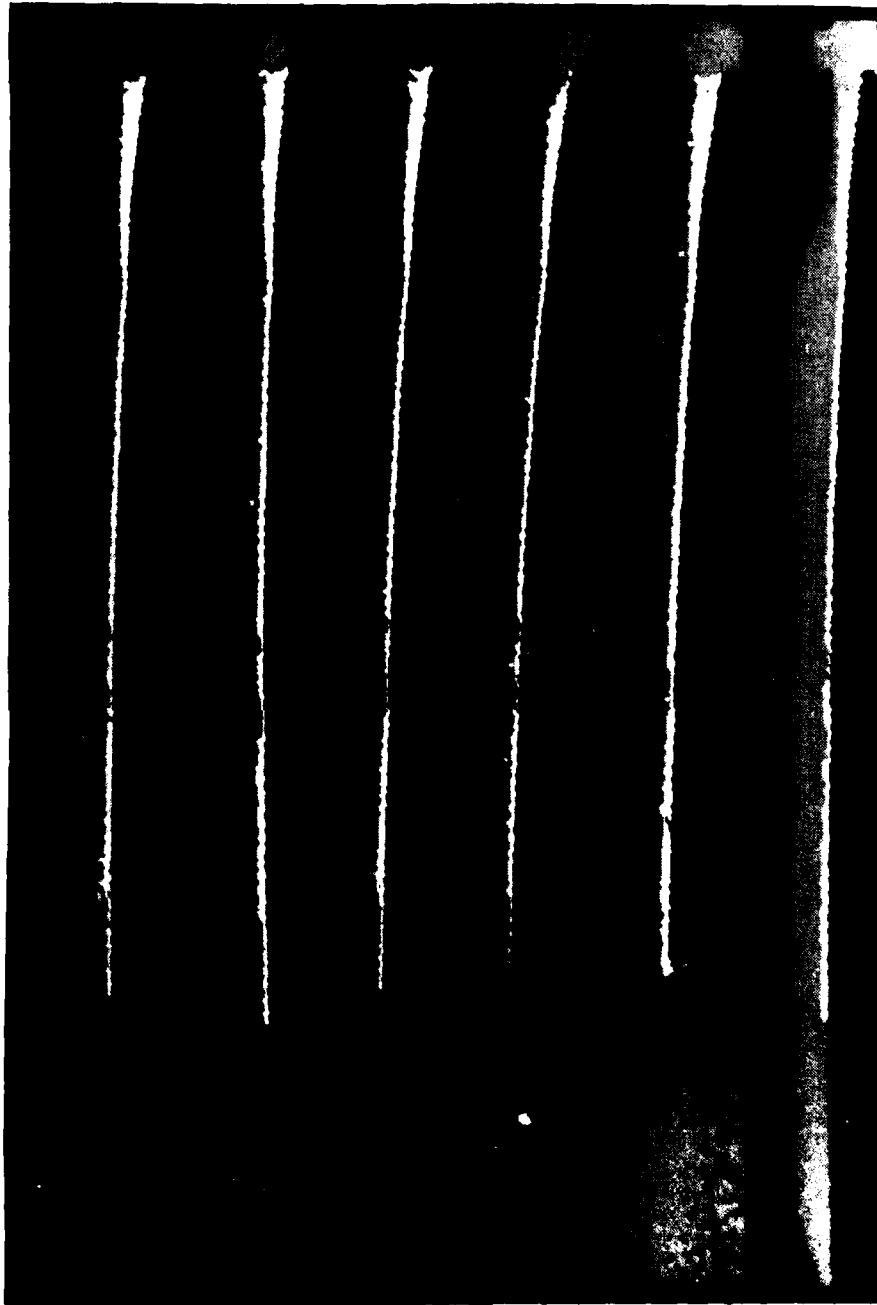
22. Ice accretion along the full span of the blade was documented on still and high speed motion photography. A camera mounted on the top of the cabin was synchronized with a single aft rotor blade. Pictures taken of flight 4, at 2-1/2 minute intervals, show the intermittent self shedding characteristics of the unheated FRB in natural icing conditions (photos 1-3, app E). The ice, depicted on the computer enhanced photographs, ends abruptly at 3/4 span of the blade and was not presented because of out of focus negatives. A computer analysis of the ice present on each blade is presented in figure 1. On flights 4 and 10, pieces of ice approximately 1 to 2 feet in length shed about blade station 180. Ice sheds were also noted in the vicinity of blade station 275. Thicker ice, as indicated by contrasting shades, was

Photo 1 of 3. Natural Ice on Aft Rotor Blade at 2½-Minute Intervals - Flight 4

Photo 2 of 3. Natural Ice on Aft Rotor Blade at 2½-Minute Intervals - Flight 4

Photo 3 of 3. Natural Ice on Aft Rotor Blade at 2½-Minute Intervals - Flight 4

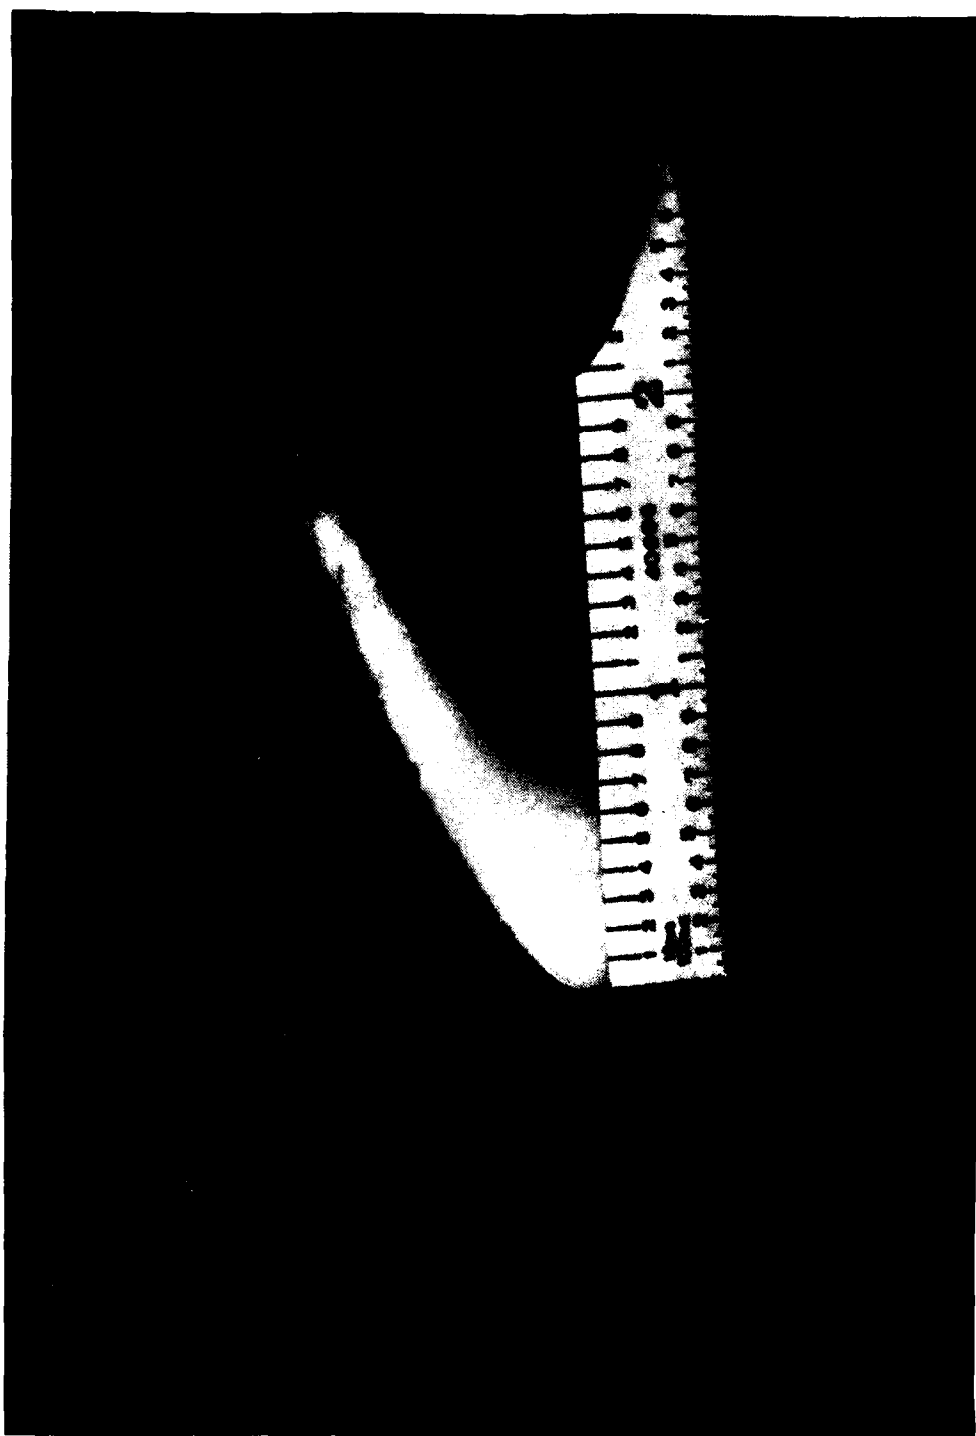
found inboard of station 180 and only a thin ice buildup occurred outboard of station 275. Pieces of ice were taken from blade station 120 after flight 4 which were 3/4 inch in thickness (photo 4).

Photo 4. Ice from Blade Station 120 - Flight 4

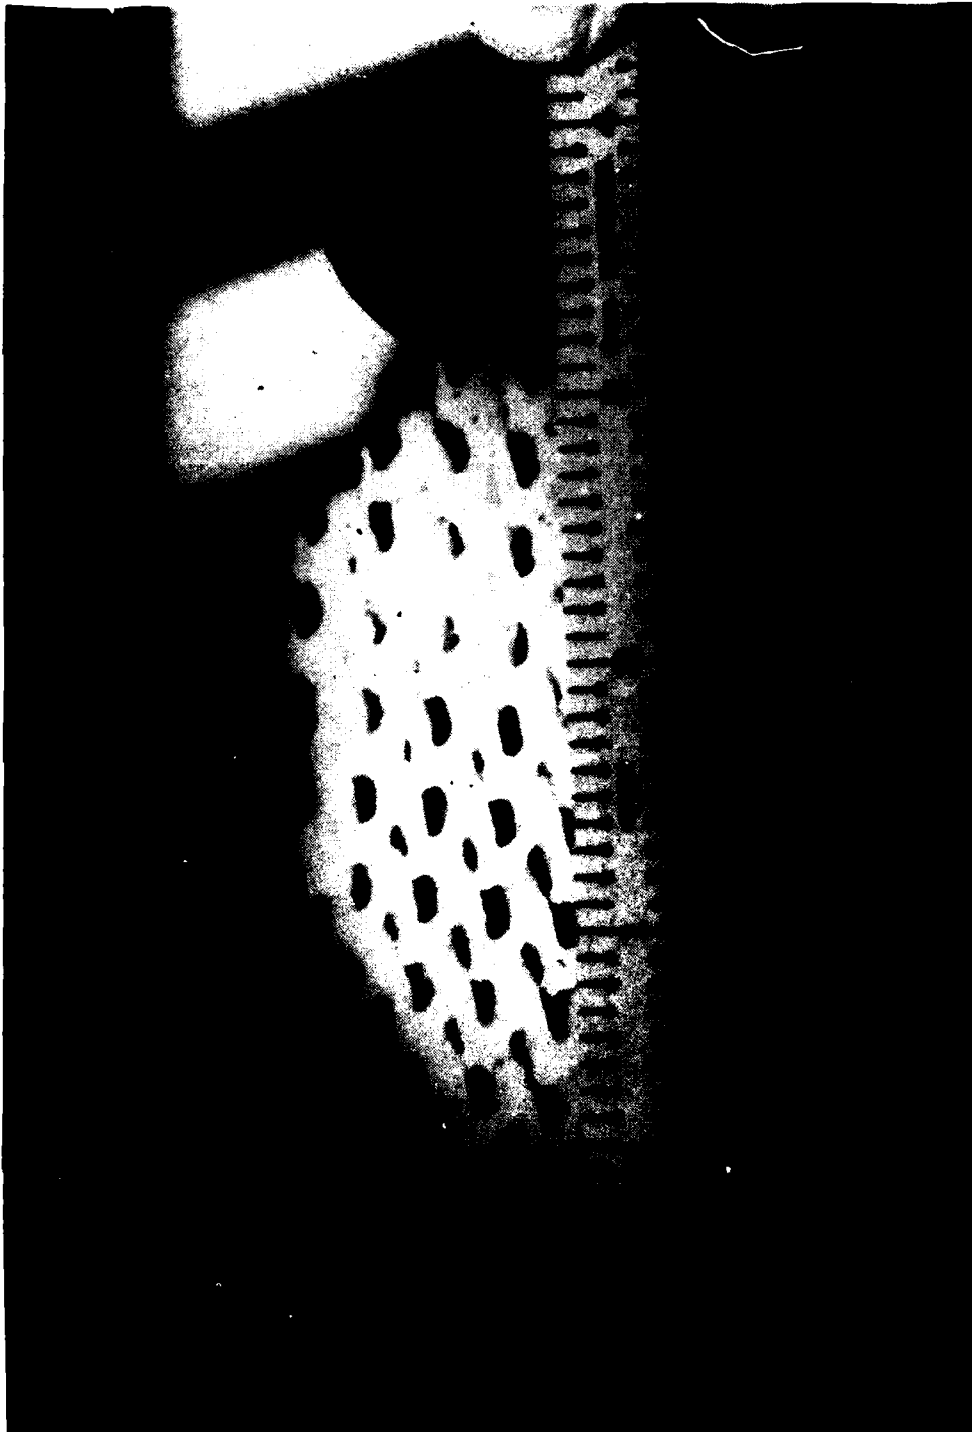
Photo 12. Natural Ice from Inlet Screens - Flight 6
